Odor Management Plan

Bristol Quarry Landfill (SWP 588)

June 7, 2021

Odor Complaint Response Plan

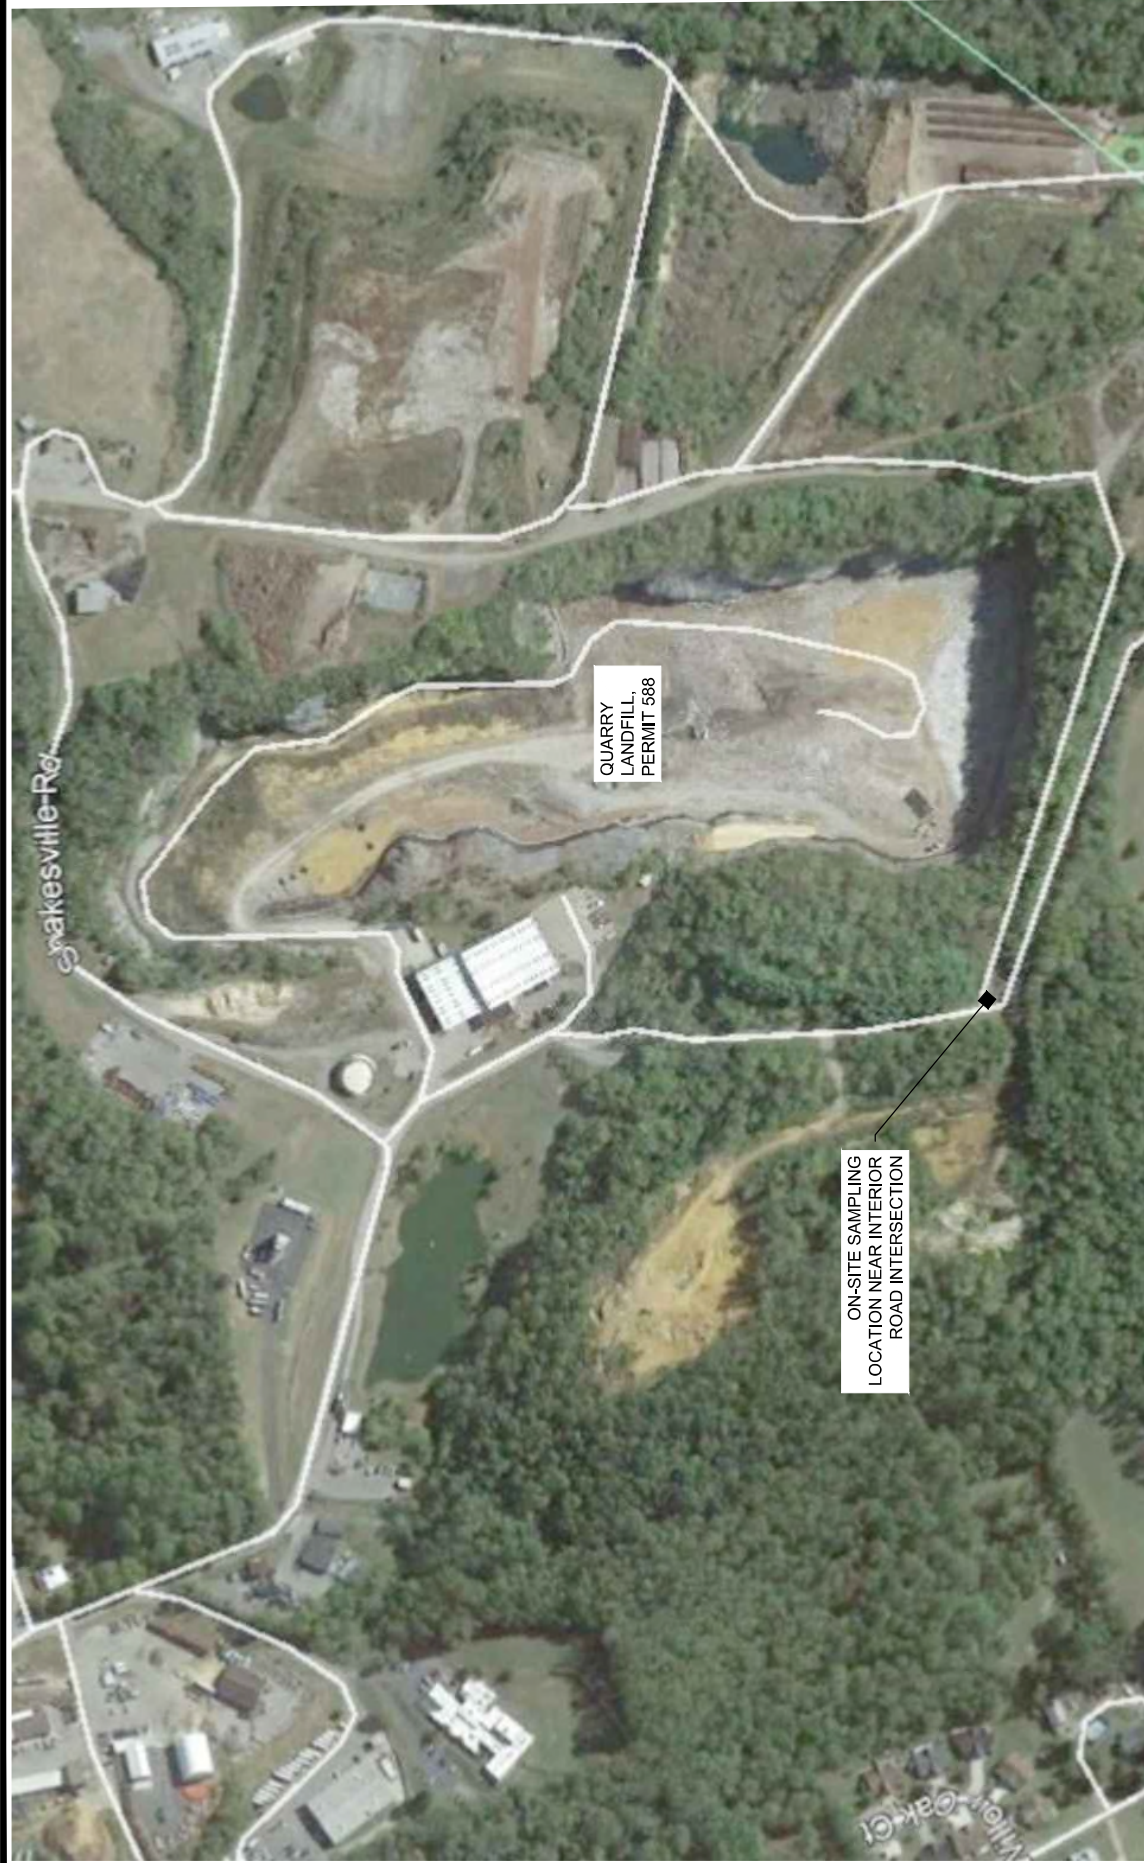
NOTES:
1. THIS MAP IS THE LEGS BRISTOL QUADRANGLE, 7.5-MINUTE SERIES DATED 2010.
2. PREVALENT WIND BASED ON WIND ROSE DATA FROM NEARBY AREA.

Draper Aden Associates Engineering • Surveying • Environmental Services 2206 South Main Street Blacksburg, VA 24060 540-552-0444 Fax: 540-552-0291 Richmond, VA Raleigh, NC Charlottesville, VA Fayetteville, NC Northern Virginia Virginia Beach, VA	DESIGNED: AST DRAWN: AST CHECKED: DATE: 03/31/2021	ODOR COMPLAINT RESPONSE PLAN BRISTOL, VIRGINIA	SCALE: 1" = 250' PROJECT: B11145B-14D	FIGURE 2
---	---	--	--	-----------------

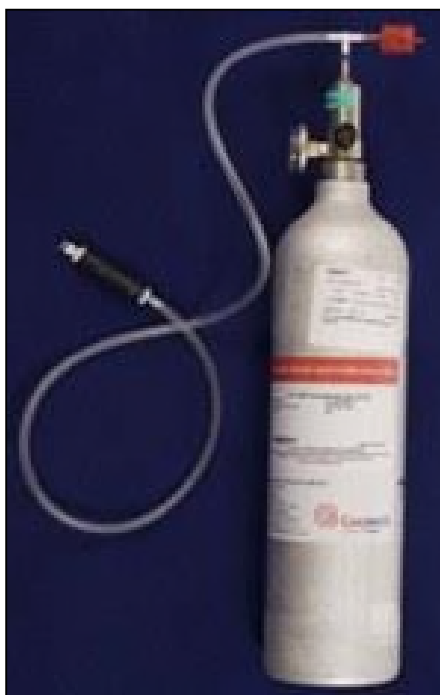
9.5 Calibration equipment

The diagram below displays the regulator and tubing equipment for user calibration:

- Certified calibration gas, available in either 29 liter, 34 liter or 58 liter gas canisters are supplied with the Landtec calibration kit. Please refer to the Landtec website www.landtecna.com for further information.
- The regulator supplied with the calibration kit is pre-set for flow and pressure rates that are factory set.
- If you are using a non Landtec supplied regulator, please ensure that it does not supply any greater than 200 mbar pressure.

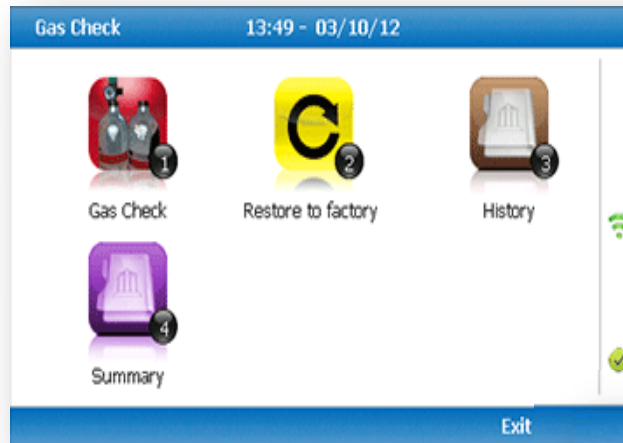
9.6 Gas analyzer

For the GEM5000 gas analyzer the calibration options can be found by selecting the 'Menu' key followed by soft-key 'Operation Settings'. Select 'Key 2 – Gas Check' then follow the instructions on the analyzer screen by selecting 'Key 2 – Gas Check'.

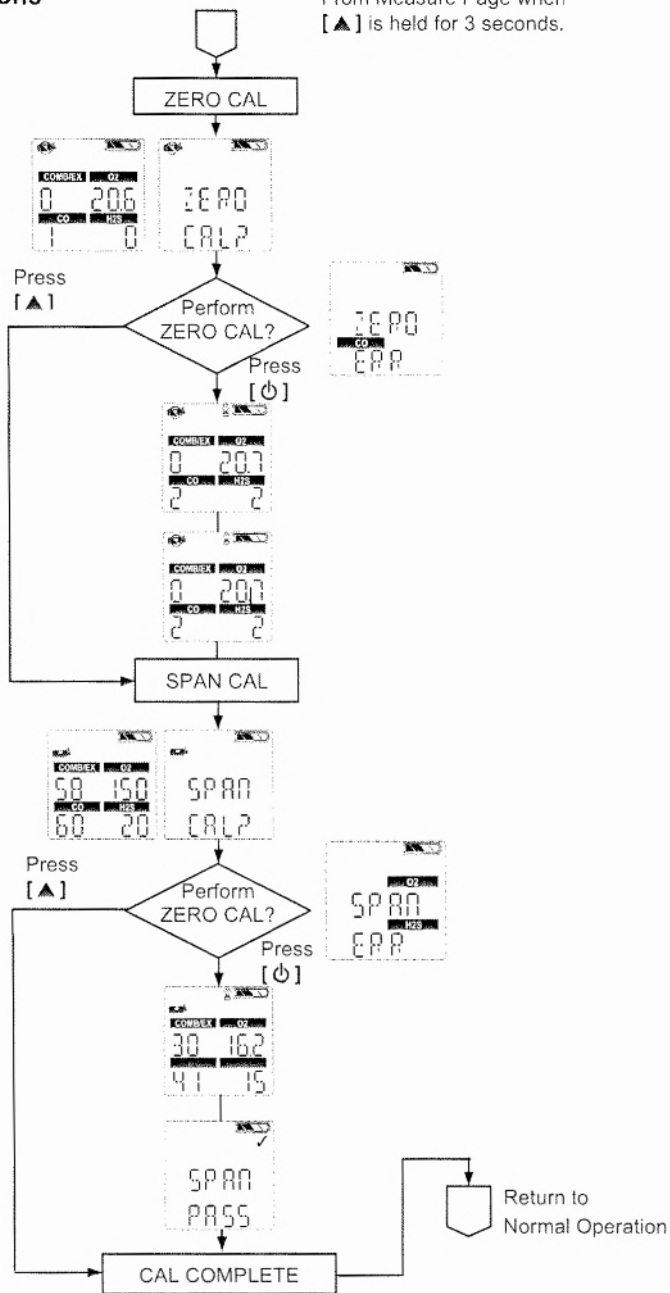
7.7 Calibrations

From Measure Page when
[▲] is held for 3 seconds.
